NOAA Technical Memorandum NMFS

SALMON HABITAT RESTORATION COST MODELING: RESULTS AND LESSONS LEARNED

NOAA-TM-NMFS-SWFSC-404

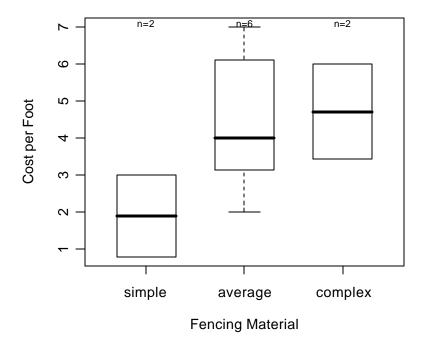
Figure 1. Box plot of cost per foot of fencing for the different fencing materials categories.

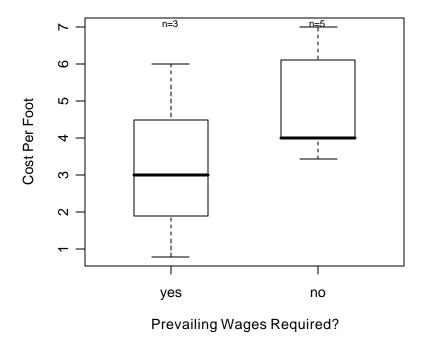
Figure 4. Box plot of cost per foot of fencing for sites where prevailing wages were and were not required.

question wasn't answered. For this reason, the data on prevailing wages were not reliable. There was not a significant difference in cost between sites where prevailing wages were and were not required (Wilcoxon signed rank test, W = 3, P = 0.23; Figure 4). The prevailing wage data were confounded with fence electrification. Where prevailing wages were required, two of the three sites involved electrified fences, and where prevailing wages were not required, none of the fences were electrified.

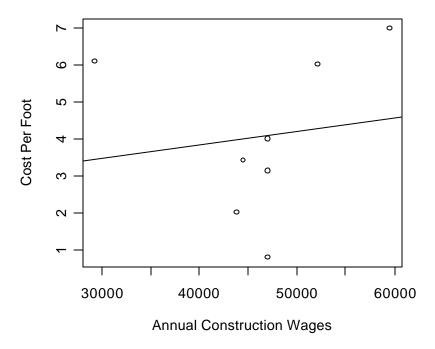
Figure 5. Cost per foot of fencing versus average annual construction wages. Line represents least squares fit.

We also looked at whether cost was associated with county-level average annual construction wages or unemployment rates. Average annual construction wages are for 'Heavy and Civil Engineering Construction' from the Covered Employment and Wages (CEW) program of the Bureau of Labor Statistics. Unemployment rates are county level Labor Force Data from the Labor Market Information Division of the California Employment Development Department. Both types of data were associated with restoration sites by year and geographic location. Some sites are missing construction wage data because data are not available for all counties for each year. There was no association between cost and either variable (Figures 5 and 6).

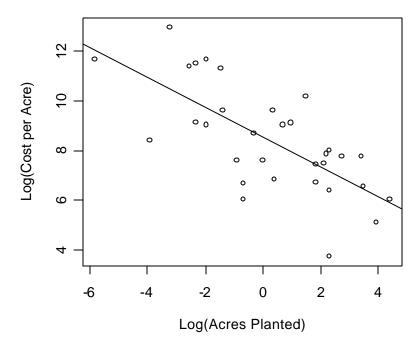
Figure 9. Log(cost per acre) versus log(acres planted) for our sample of one riparian planting site per project.

Log transformed cost per acre was significantly associated with the log-transformed number of acres planted (Regression, coef. = -0.61, P = 0.000008, R²adj = 0.47; Figure 9). Larger projects tend to cost less per acre, indicating that there are some economies of scale with riparian planting projects. A 1% increase in area planted results in a 0.61% decrease in cost per acre.

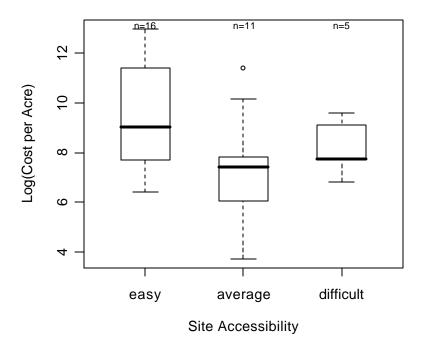
Figure 10. Boxplot of log(cost per acre) for each site accessibility class for our sample of one riparian planting site per project.

There was a marginally significant difference in log-transformed cost per acre among the different site accessibility classes (Kruskal-Wallis chi-squared = 5.78, df = 2, P = 0.056; Figure 10).

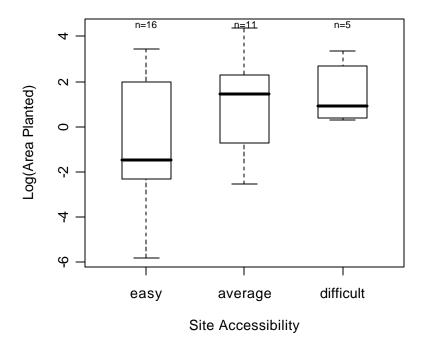
Figure 11. Boxplot of log(area planted) for each site accessibility class for our sample of one riparian planting site per project.

There was also a marginally significant difference in log-transformed area planted among the different site accessibility classes (Kruskal-Wallis chi-squared = 4.73, df = 2, p-value = 0.09; Figure 11).

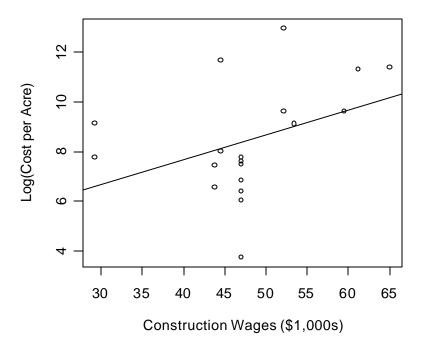
Figure 17. Cost per acre for riparian planting versus average annual construction wages for our sample of one riparian planting site per project. Line represents least squares fit.

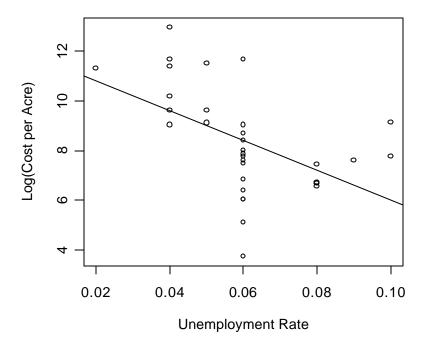
Figure 18. Cost per acre for riparian planting versus average unemployment rate for our sample of one riparian planting site per project. Line represents least squares fit.

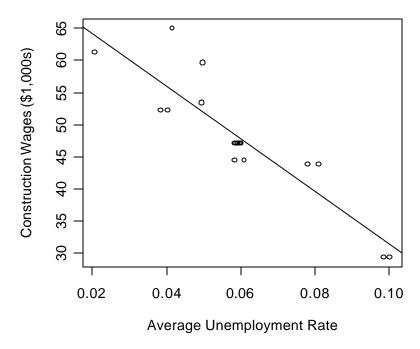
Figure 19. Average annual construction wages versus average unemployment for riparian planting sites for our sample of one riparian planting site per project. Points are offset to show multiple points in the same location.

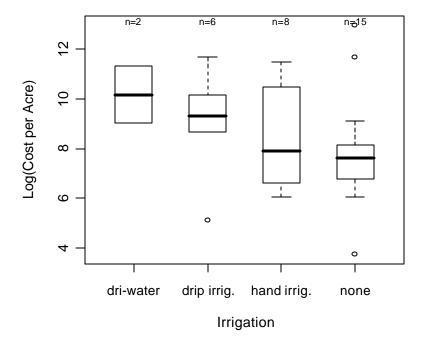
Figure 20. Boxplot of log(cost per acre) for riparian planting sites with different irrigation types for our sample of one riparian planting site per project.

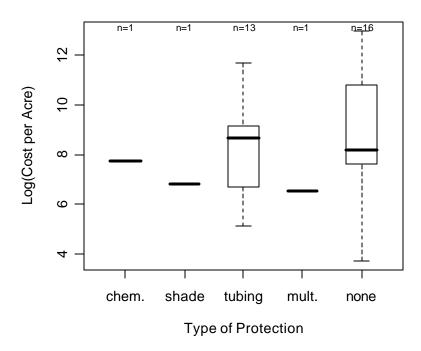
Figure 21. Boxplot of log(cost per acre) for each protection type for our sample of one riparian planting site per project.

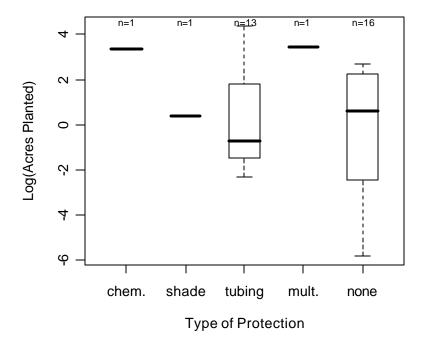
Figure 22. Boxplot of log(acres planted) for each protection type for our sample of one riparian planting site per project.

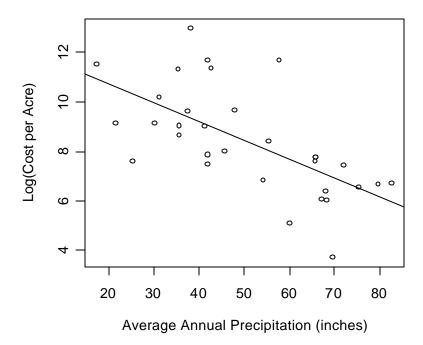
Figure 23. Log(cost per acre) versus average annual precipitation for the climatologic period 1961-1990 (inches) for our sample of one riparian planting site per project.

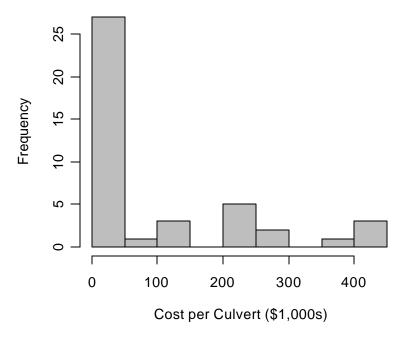
Figure 24. Histogram of cost per culvert for all culvert replacement projects.

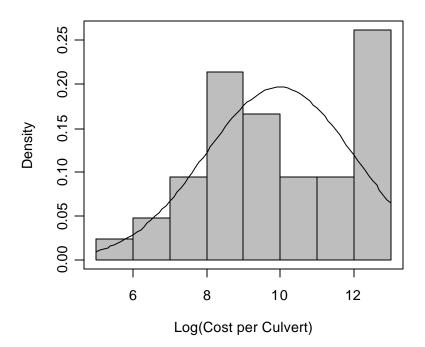
Figure 25. Probability density of log-transformed cost per culvert for all culvert replacement projects.

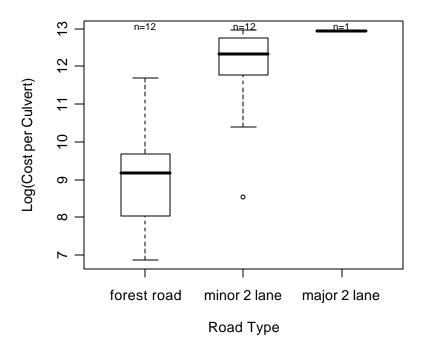
Figure 26. Boxplot of log(cost per culvert) for culvert replacement sites with different road types for our sample of one culvert replacement site per project.

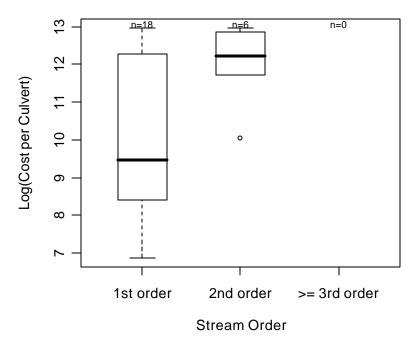
Figure 27. Boxplot of log(cost per culvert) by stream order for our sample of one culvert replacement site per project.

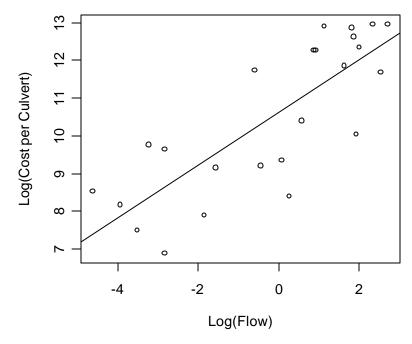
Figure 29. Log(cost per culvert) versus log(stream flow) for our sample of one culvert replacement site per project. Line represents least squares fit. Flow values are measured in cubic feet per second.

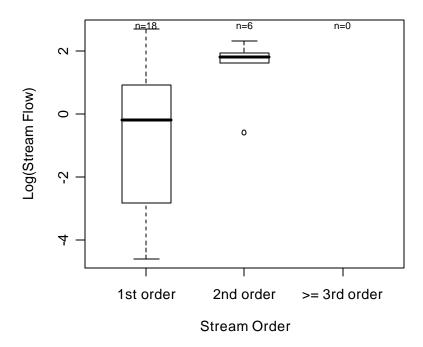
Figure 30. Boxplot of log(stream flow) for each stream order. Flow values are measured in cubic feet per second.

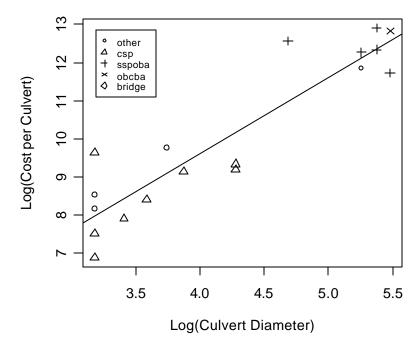
Figure 32. Log(cost per culvert) versus log(culvert diameter) for our sample of one culvert replacement site per project. Line represents least squares fit. Diameter is measured in inches. Culvert types are distinguished by symbols: csp = corrugated steel pipe, sspoba = structural steel pipe open bottom arch, obcba = open bottom concrete box arch.

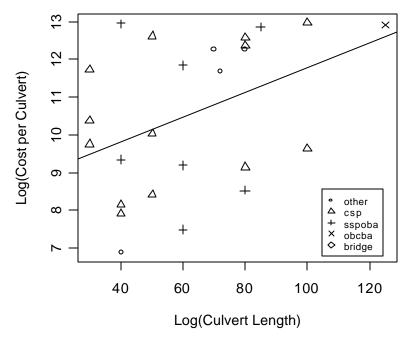
Figure 33. Log(cost per culvert) versus culvert length for our sample of one culvert replacement site per project. Line represents least squares fit. Length is measured in feet. Culvert types are distinguished by symbols: csp = corrugated steel pipe, sspoba = structural steel pipe open bottom arch, obcba = open bottom concrete box arch.

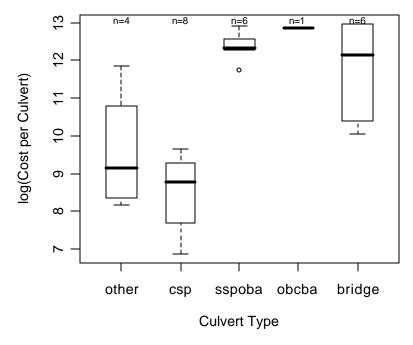
Figure 34. Boxplot of log(cost per culvert) for each culvert type for our sample of one culvert replacement site per project. csp = corrugated steel pipe, sspoba = structural steel pipe open bottom arch, obcba = open bottom concrete box arch.

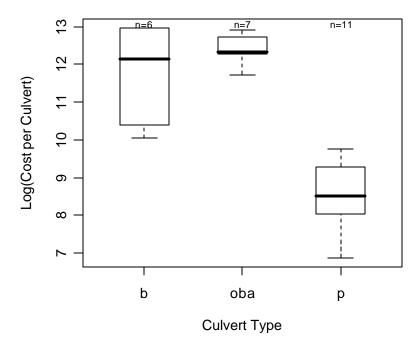
Figure 35. Boxplot of log(cost per culvert) for each culvert type for our sample of one culvert replacement site per project. b = bridge, oba = open-bottom arch, p = pipe.

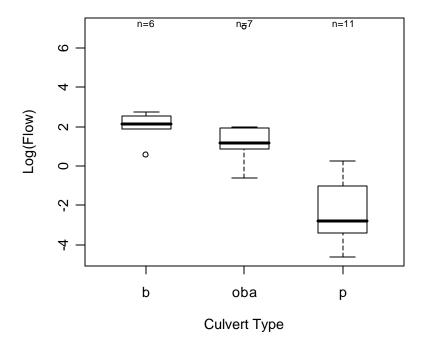
Figure 36. Boxplot of log(flow) for each culvert type for our sample of one culvert replacement site per project. b = bridge, oba = open-bottom arch, p = pipe.

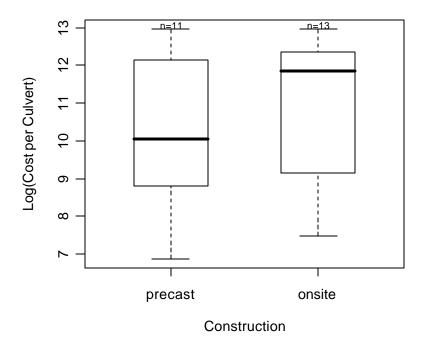
Figure 37. Boxplot of log(cost per culvert) for projects with precast culverts and culverts constructed onsite.

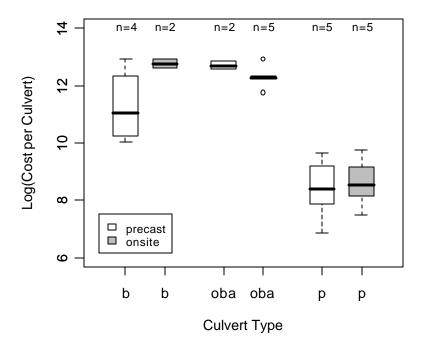
Figure 38. Boxplot of log(cost per culvert) by culve rt type and construction type for our sample of one culvert replacement site per project. b = bridge, oba = open bottom arch, p = pipe.

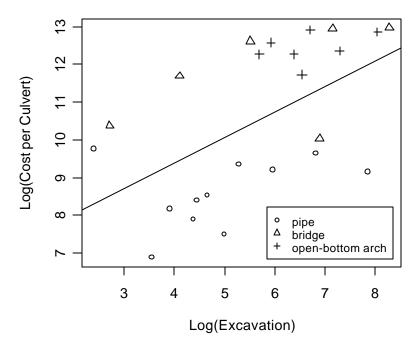
Figure 39. Log(cost per culvert) versus log(excavation). Line represents least squares fit. Excavation is measured in cubic yards.

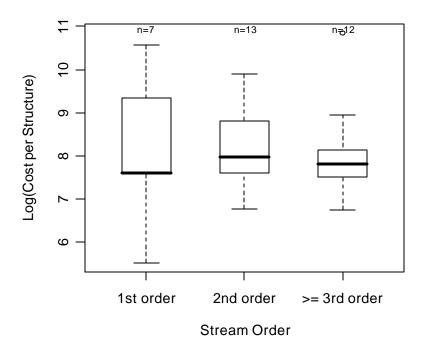
Figure 42. Boxplot of log(cost per structure) by stream order for our sample of one instream structure site per project.

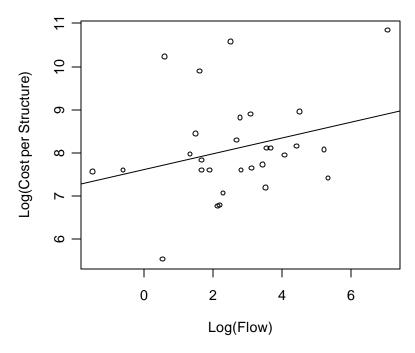
Figure 44. Log(cost per structure) versus log(stream flow) for our sample of one instream structure site per project. Line represents least squares fit. Flow values are measured in cubic feet per second.

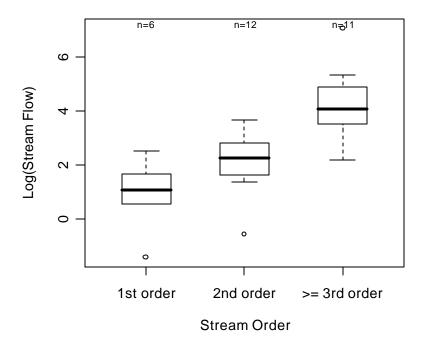
Figure 45. Boxplot of log(stream flow) for each stream order for our sample of one instream structure site per project. Flow values are measured in cubic feet per second.

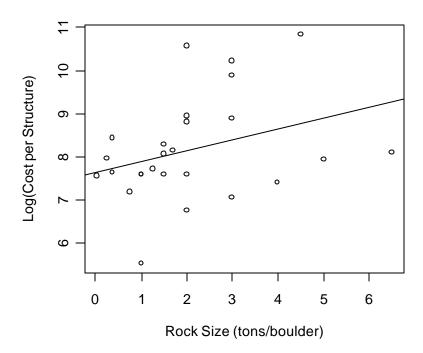
Figure 48. Log(cost per structure) versus rock size (tons/boulder) for our sample of one instream structure site per project.

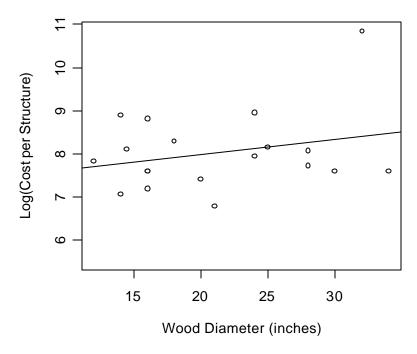
Figure 49. Log(cost per structure) versus wood diameter (inches) for our sample of one instream structure site per project.

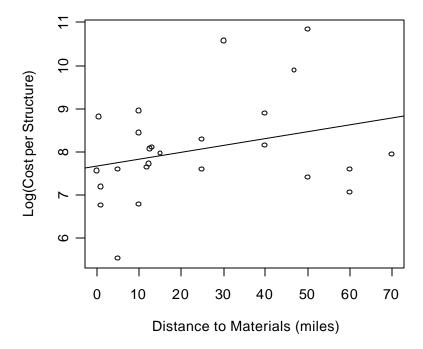
Figure 50. Log(cost per structure versus distance to materials (miles) for our sample of one instream structure site per project.

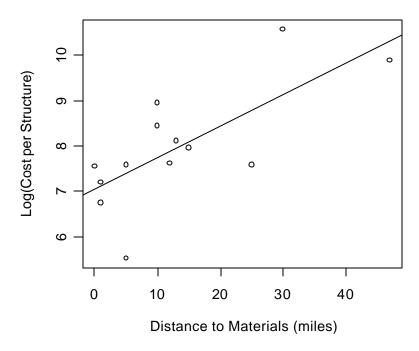
Figure 51. Log(cost per structure) versus distance to materials (miles) for the subset of sites with rock as the primary structure material.

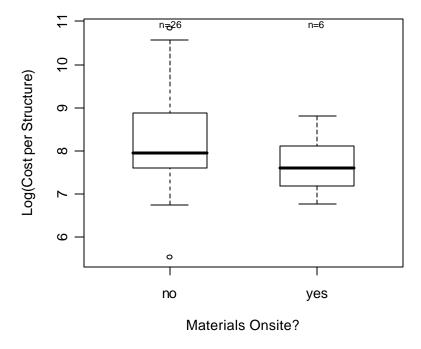
Figure 52. Boxplot of log(cost per structure) for instream structures sites with and without materials available onsite for our sample of one instream structure site per project.

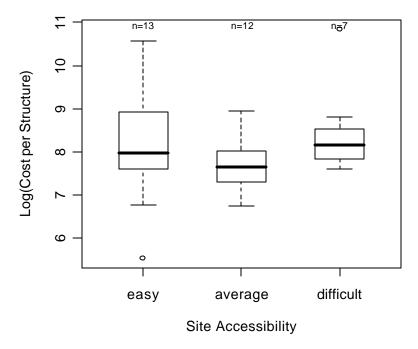
Figure 53. Boxplot of log(cost per acre) for each site accessibility class for our sample of one instream structure site per project.

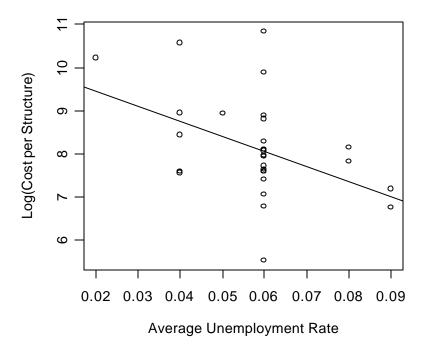
Figure 56. Log(cost per structure) versus average annual unemployment rate for our sample of one instream structure site per project.

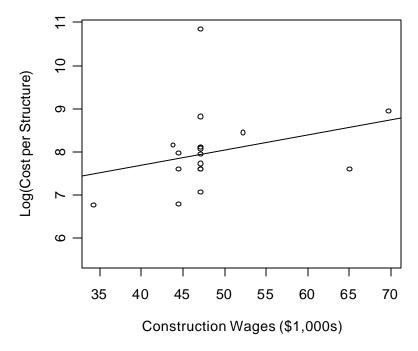
Figure 57. Log(cost per structure) versus average annual construction wages for our sample of one instream structure site per project.

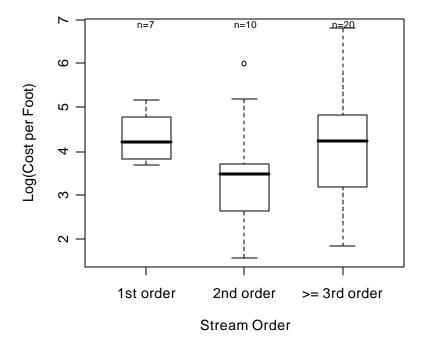
Figure 59. Boxplot of log(cost per foot) of bank stabilization by stream order for the sample of one site per project.

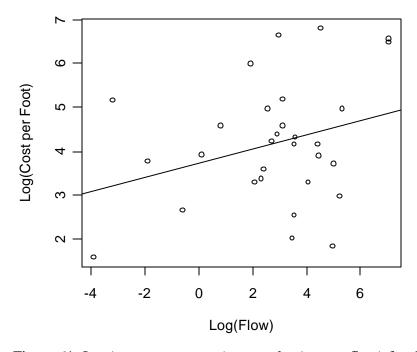
Figure 61. Log(cost per structure) versus log(stream flow) for the sample of one bank stabilization site per project. Line represents least squares fit. Flow values are measured in cubic feet per second.

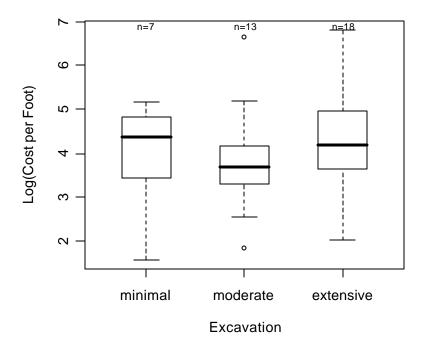
Figure 63. Boxplot of log(cost per foot) for each excavation type for the samples of one bank stabilization site per project.

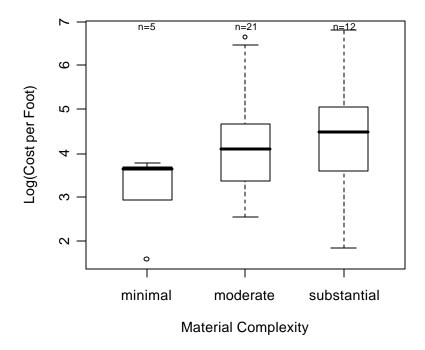
Figure 64. Boxplot of log(cost per foot) for each material complexity class for the sample of one bank stabilization site per project.

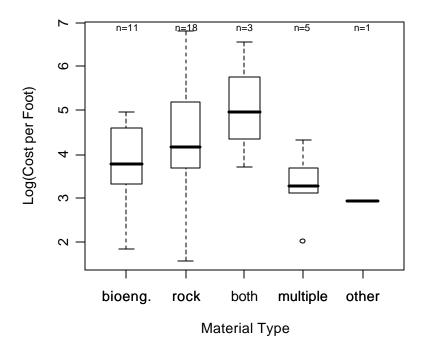
Figure 66. Boxplot of log(cost per foot) for each material type for the sample of one bank stabilization site per project. Material types: bioengineered, rock, both rock and wood, multiple types, and other.

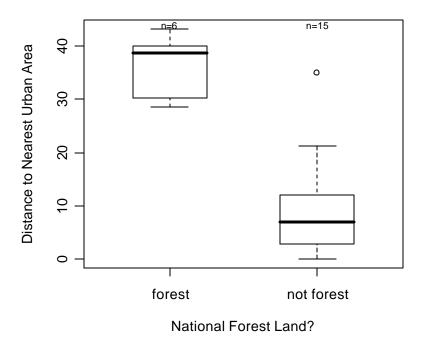
Figure 73. Boxplot of distance to nearest urban area (miles) for sites that are and are not on National Forest lands.

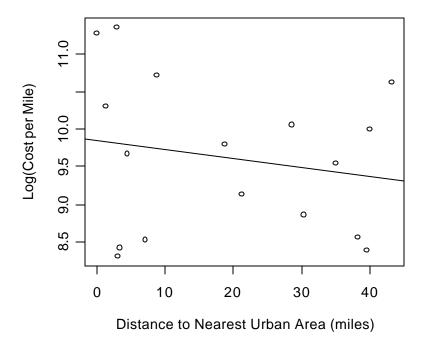
Figure 75. Log(cost per mile) versus distance to nearest urban area (miles) for our sample of one road decommissioning site per project. Line represents least squares fit.

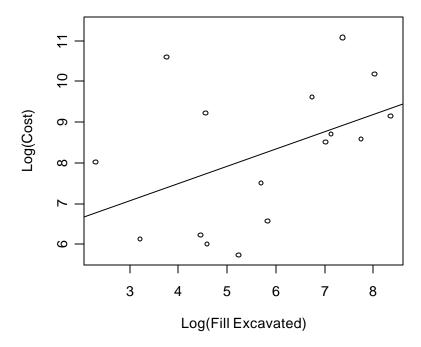
Figure 85. Log(cost) versus log(fill excavated) for our sample of one road decommissioning site per project. Fill excavated is measured in cubic yards.

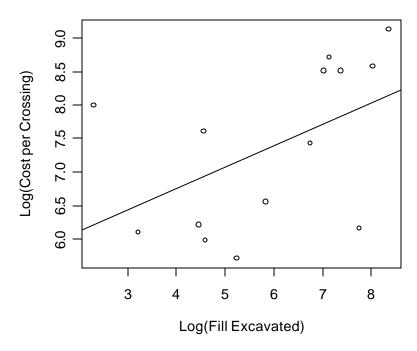
Figure 86. Log(cost per crossing) versus log(fill excavated) for our sample of one road decommissioning site per project.

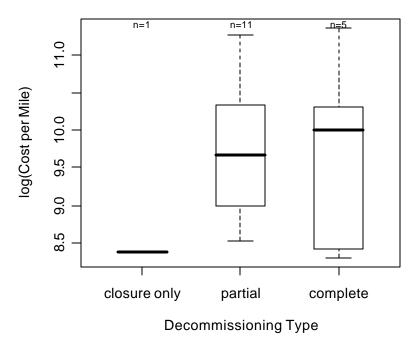
Figure 88. Boxplot of log(cost per mile) for each type of road decommissioning for our sample of one road decommissioning site per project.

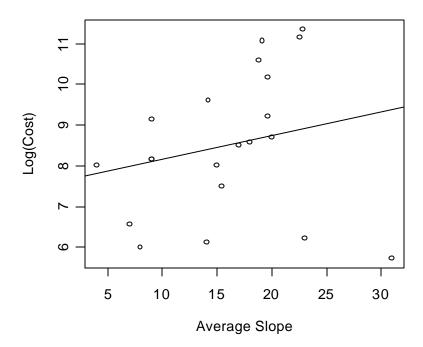
Figure 89. Log(cost) versus average slope for our sample of one road decommissioning site per project.

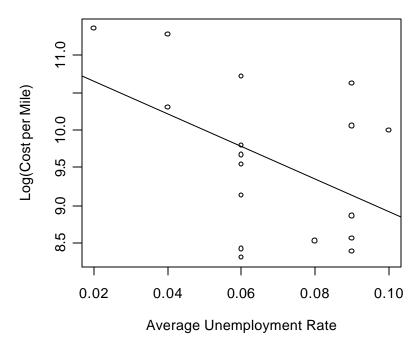
Figure 91. Log(cost per mile) versus average annual unemployment rate for our sample of one road decommissioning site per project.

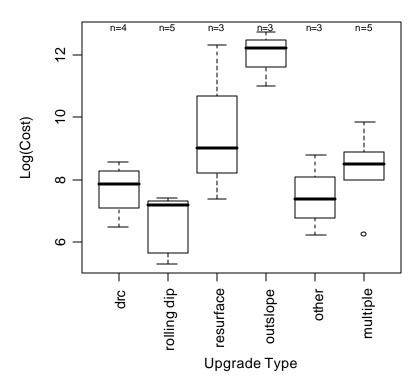
Figure 93. Boxplot of log(cost) for each upgrade type for our sample of one road upgrade site per project.

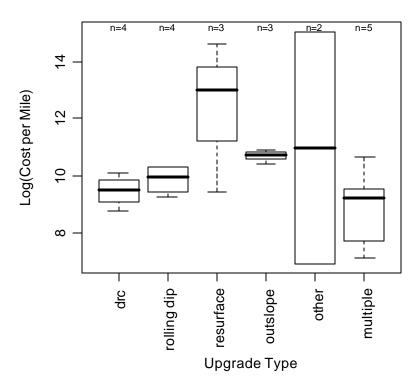
Figure 94. Boxplot of log(cost per mile) for each upgrade type for our sample of one road upgrade site per project.

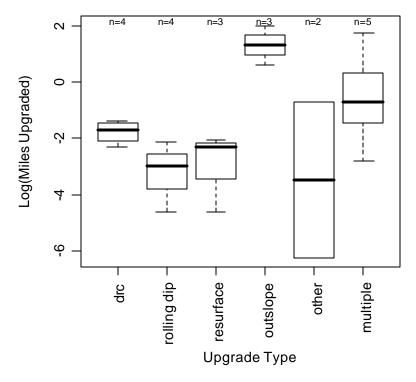
Figure 95. Boxplot of log(miles upgraded) for each upgrade type for our sample of one road upgrade site per project.

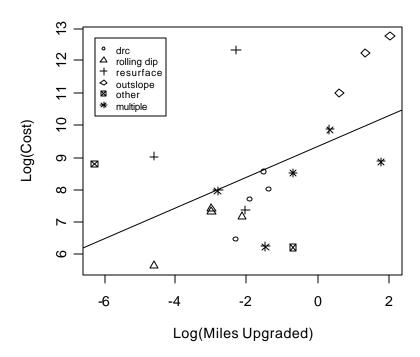
Figure 96. Log(cost) versus log(miles upgraded) for our sample of one road upgrade site per project. Upgrade types are distinguished by different symbols.

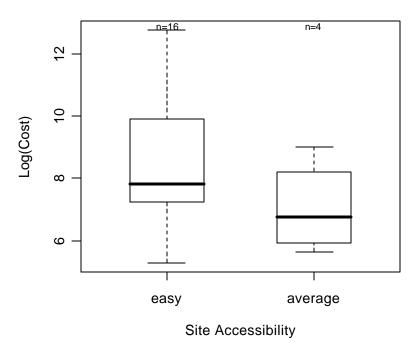
Figure 98. Boxplot of log(cost) for each site accessibility category for our sample of one road upgrade site per project.

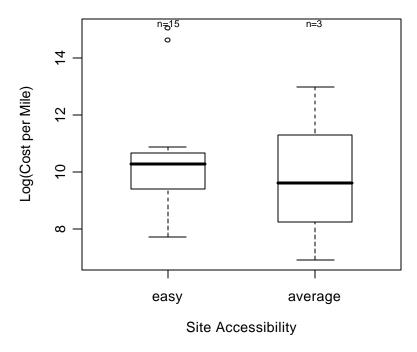
Figure 99. Boxplot of log(cost per mile) for each site accessibility class for our sample of one road upgrade site per project.

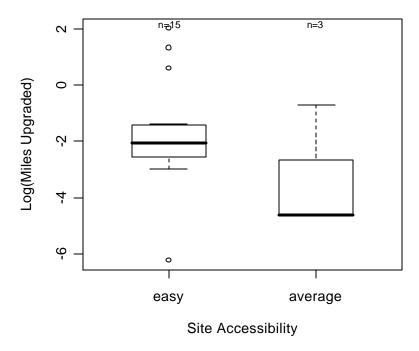
Figure 100. Boxplot of log(miles upgraded) for each site accessibility class for our sample of one road upgrade site per project.

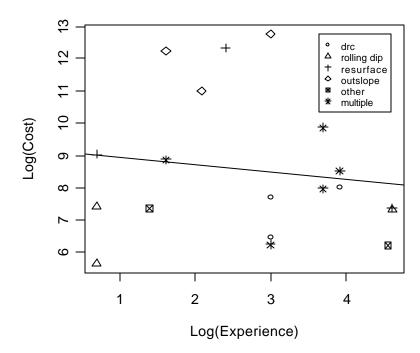
Figure 101. Log(cost) versus log(experience) for our sample of one road upgrade site per project. Upgrade types are distinguished by different symbols. Experience is measured as estimated number of similar projects the contractor has worked on.

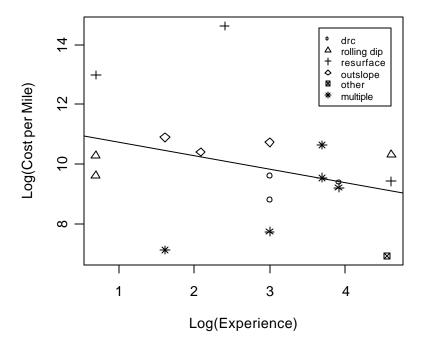
Figure 102. Log(cost per mile) versus log(experience) for our sample of one road upgrade site per project. Upgrade types are distinguished by different symbols. Experience is measured as estimated number of similar projects the contractor has worked on.

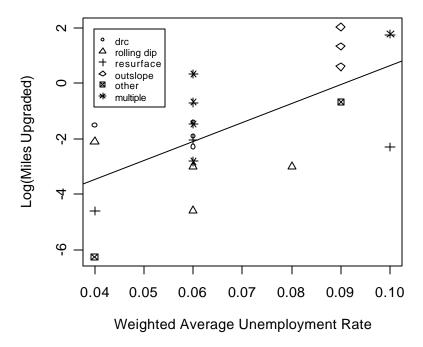
Figure 110. Log(miles upgraded) versus weighted average unemployment rate for our sample of one road upgrade site per project. Upgrade types are distinguished by different symbols.

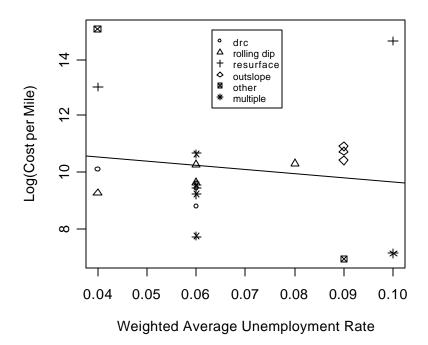
Figure 111. Log(cost per mile) versus weighted average unemployment rate for our sample of one road upgrade site per project. Upgrade types are distinguished by different symbols.

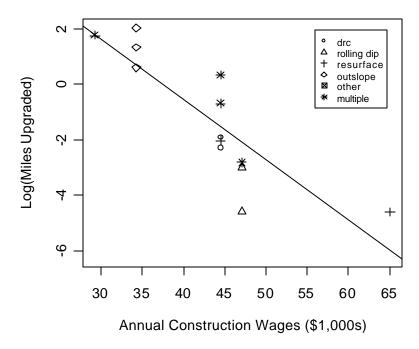
Figure 113. Log(miles upgraded) versus weighted average annual construction wages for our sample of one road upgrade site per project. Upgrade types are distinguished by different symbols.

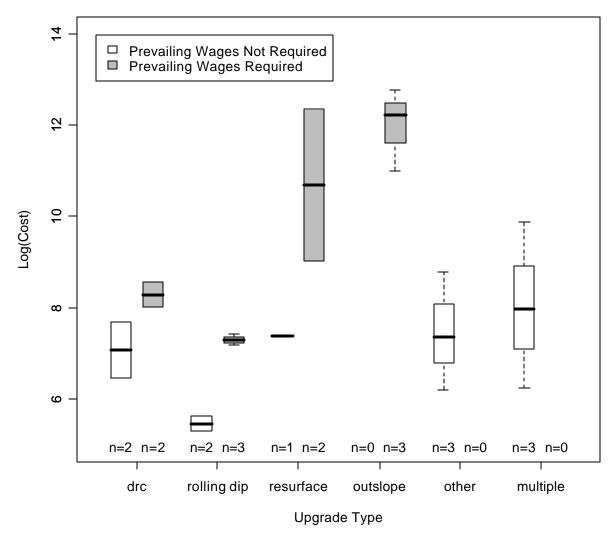
Figure 116. Boxplot of log(cost) for sites where prevailing wages were and were not required for each road upgrade type for our sample of one road upgrade site per project.

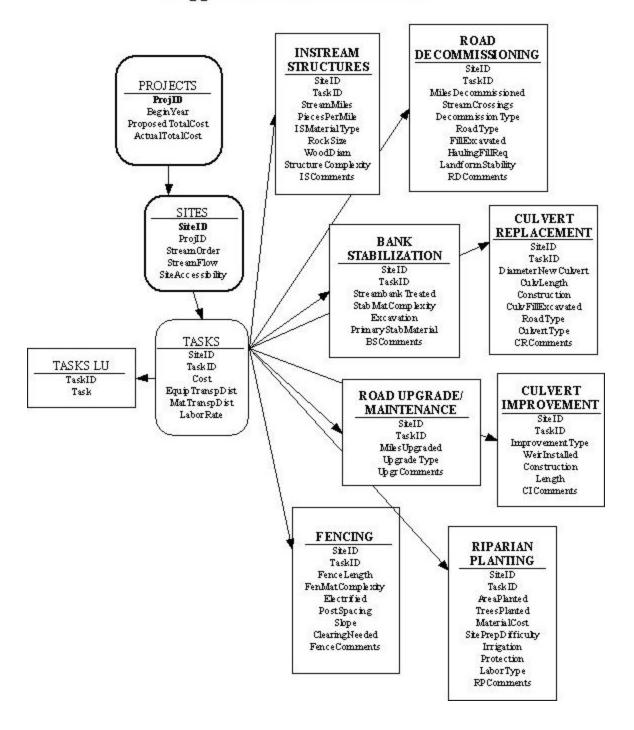
Figure 122. Schematic of a proposed database structure for collecting detailed restoration project data.
